Manhole Inspection Summary

Manhole # S4100_029MH

Insp Date: **2/21/07 9:33 AM**

Location Address: **2116 AIKEN ST**

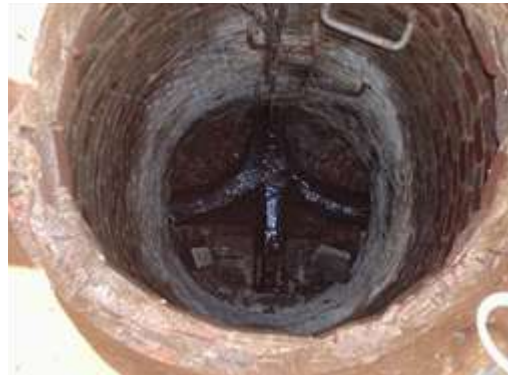
Top View

Corroded steps. Evidence of surcharge - Bench debris.

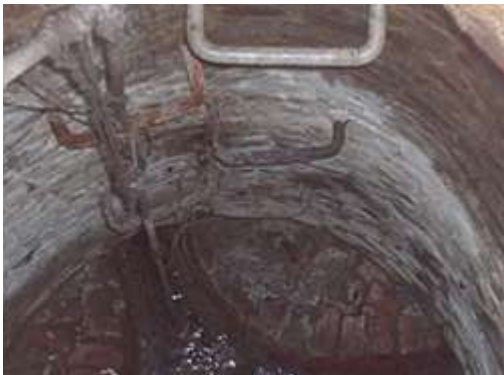
Defect

Barrel infiltration.

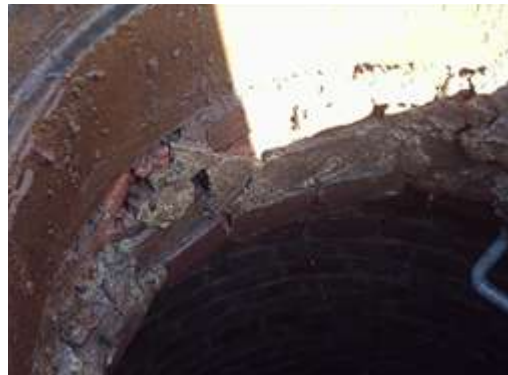
Defect

Frame leaks. Frame offset. Adjustment deterioration, loose brick and infiltration.

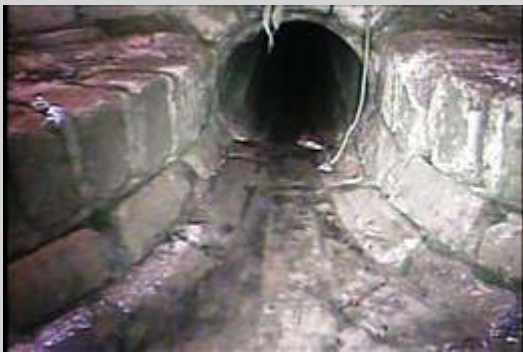
8 in. Circular Gravity Sewer Pipe Out @ 12 O'Clock

Channel deterioration.

Infiltration: **Evidence** Pipe Seal Cond: **Roots**

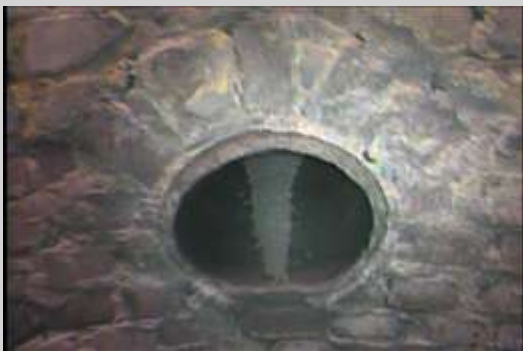
8 in. Circular Gravity Sewer Pipe In @ 3 O'Clock

Infiltration: **Evidence** Pipe Seal Cond: **Unknown**

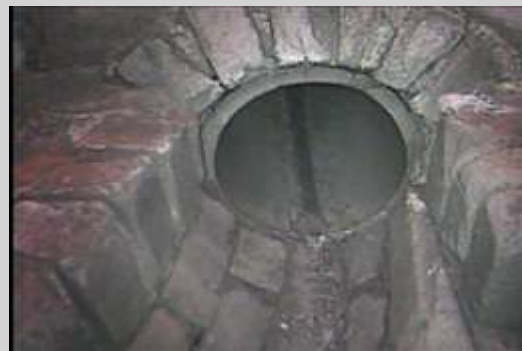
Drop In @ 3 O'Clock

Drop: **Outside** Rod and Bar

Drop Condition: **Open**

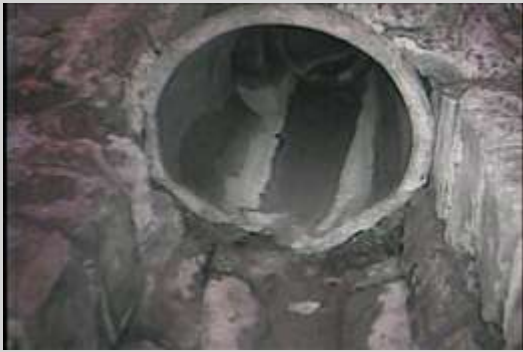
Pipe In @ 6 O'Clock

Pipe Seal Cond: **Broken**

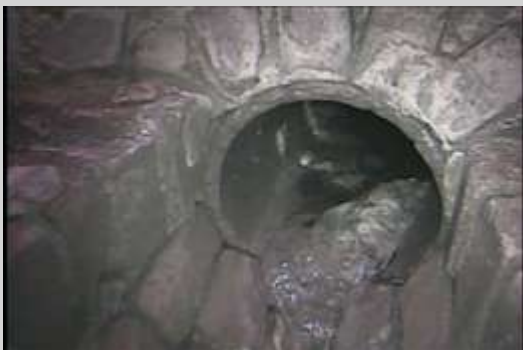
Pipe In @ 9 O'Clock

Deposits: ☐ None ☐ Mud ☐ Sludge ☒ **Debris** ☐ Grease

Silt Depth: **0** (in.) Deposits Extent: **Light**

Infiltration: **Evidence**
